MEMORANDUM ASBESTOS SURVEY FINAL REPORT CNC CHARLESTON SC
3/1/1998
ENVIRONMENTAL DETACHMENT CHARLESTON

Subj: **ASBESTOS SURVEY FINAL REPORT, Charleston Naval Base Housing**

NAVAL HOUSING CHARLESTON NAVAL BASE CHARLESTON, SOUTH CAROLINA

ASBESTOS INSPECTION REPORT

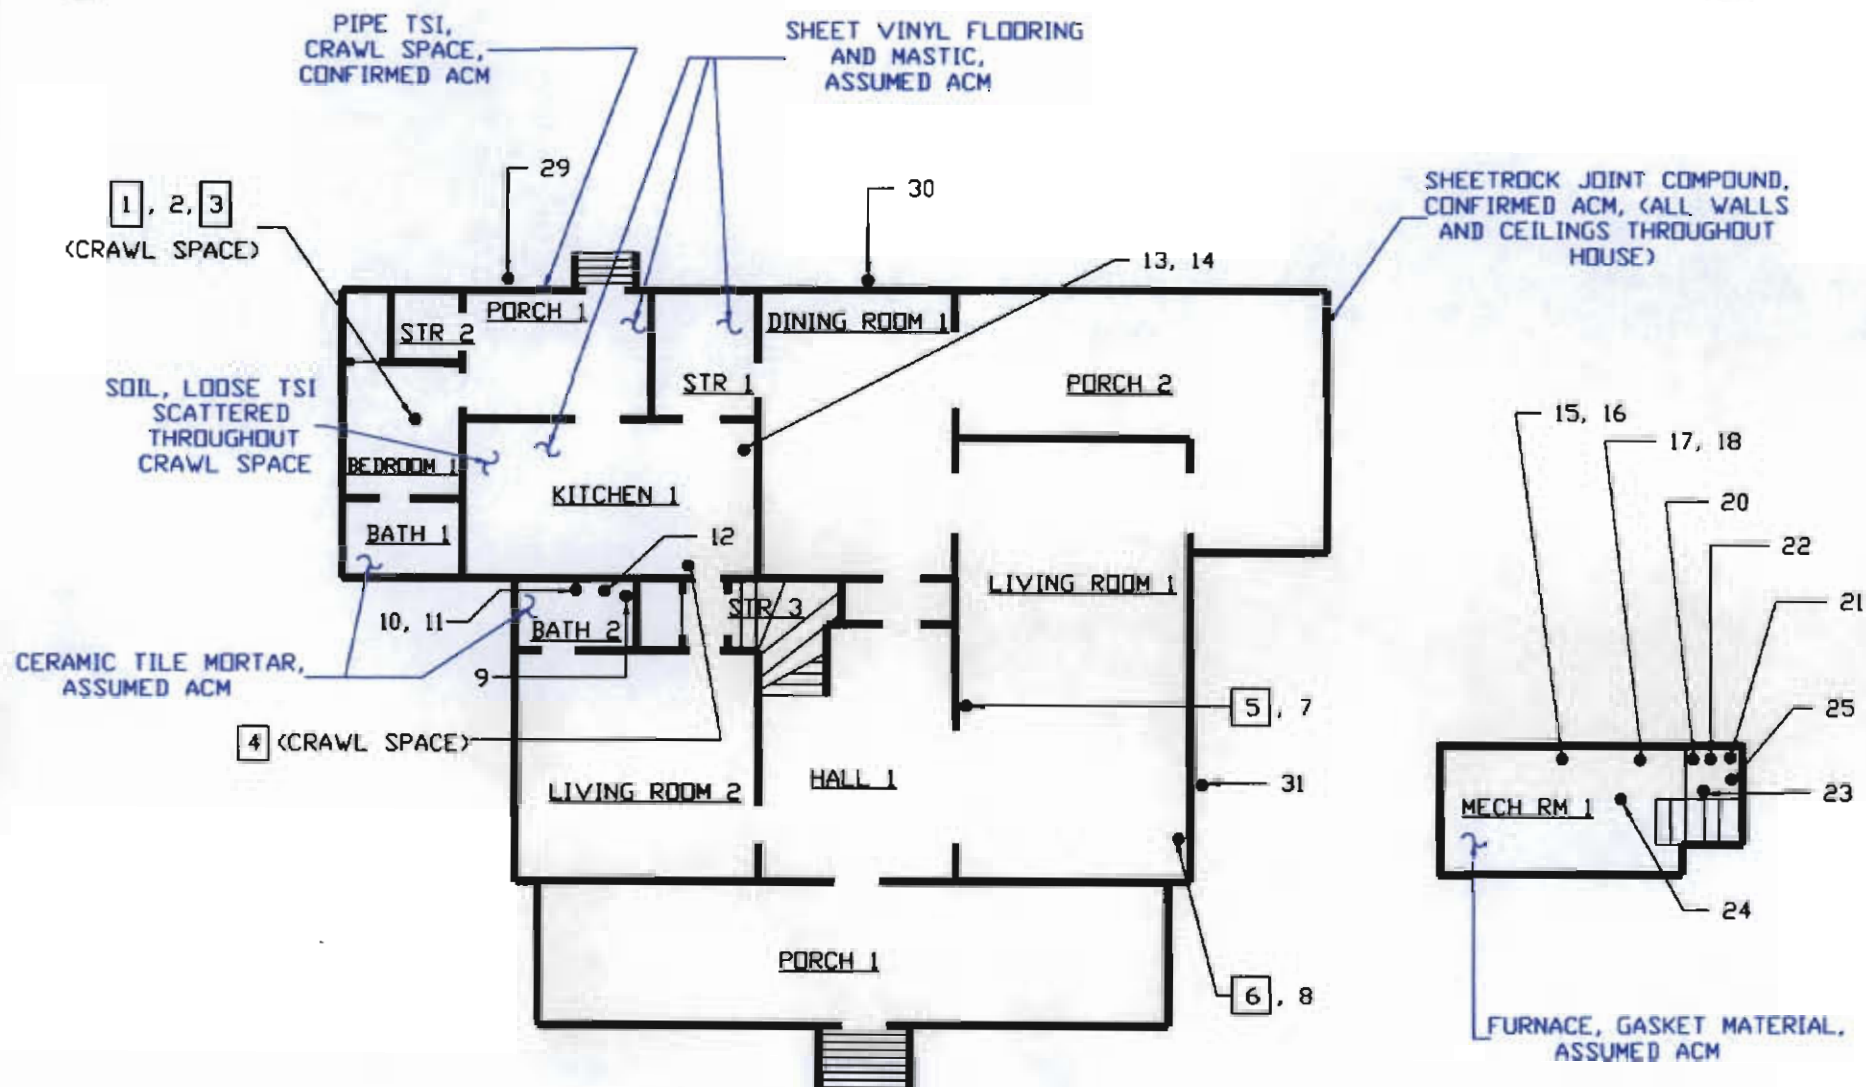
Floor Plan
200 NAVY WAY - QUARTERS "B"
Charleston Naval Base
Charleston, SC

1. PIPING TSI, located in crawl space
2. PIPING TSI, located in attic
3. SOIL, loose pieces of TSI scattered throughout crawl space soil
4. ATTIC INSULATION UNDER DETERIORATING PIPE TSI, attic insulation is non-asbestos but has been contaminated by falling debris from pipe TSI
5. SHEETROCK JOINT COMPOUND, all walls and ceilings throughout house.

Sample No.	ACM Y / N / A	Material Description / LOCATION	Quantity	AHERA CATEGORY	FRIABLE	Cond	% D	Recommended Action	Comments
200-NW-3	Y Y	PIPE TSI, crawl space	130 LF	1	YES	SD	15	REMOVE	some piping tsi in crawl space has previously been replaced
200-NW-26	Y	PIPE TSI, attic	160 LF	1	YES	SD	15	REMOVE	
200-NW-1 200-NW-4	Y Y	SOIL, loose TSI scattered throughout crawl space soil	2000 sq. ft.	1	YES	SD	100	Remove loose TSI and soil.	
200-NW-27 200-NW-28	N Y	ATTIC INSULATION UNDER DAMAGED PIPE TSI	480 sq. ft.	1	YES	SD	100	REMOVE	Pipe tsi has deteriorated and fell on attic insulation. Attic insulation is non- asbestos.
200-NW-5 200-NW-6 200-NW-19	Y Y Y	MISC., SHEETROCK JOINT COMPOUND, walls and ceilings throughout house	11,320 sq. ft.	5	Only where Damaged	D	< 1	Repair damage	<ul style="list-style-type: none"> Bedroom # 4, ceiling has water damage, approx. 4 sq. ft. Living room # 1 has water damage, approx. 4 sq. ft.

ASSUMED	A	MISC., SHEET VINYL FLOORING, kitchen and porch 3	300 sq. ft.	6	NO	G	< 1	O & M	tested positive in other Charleston Naval housing units
ASSUMED	A	MISC., SHEET VINYL FLOORING, bathroom 3 and 4	115 sq. ft.	6	NO	G	< 1	O & M	tested positive in other Charleston Naval housing units
ASSUMED	A	MISC., CERAMIC TILE MORTAR, all bathrooms	445 sq. ft.	8	NO	G	0	O & M	
ASSUMED	A	FURNACE	*	*	*	*	*	*	gen note # 3

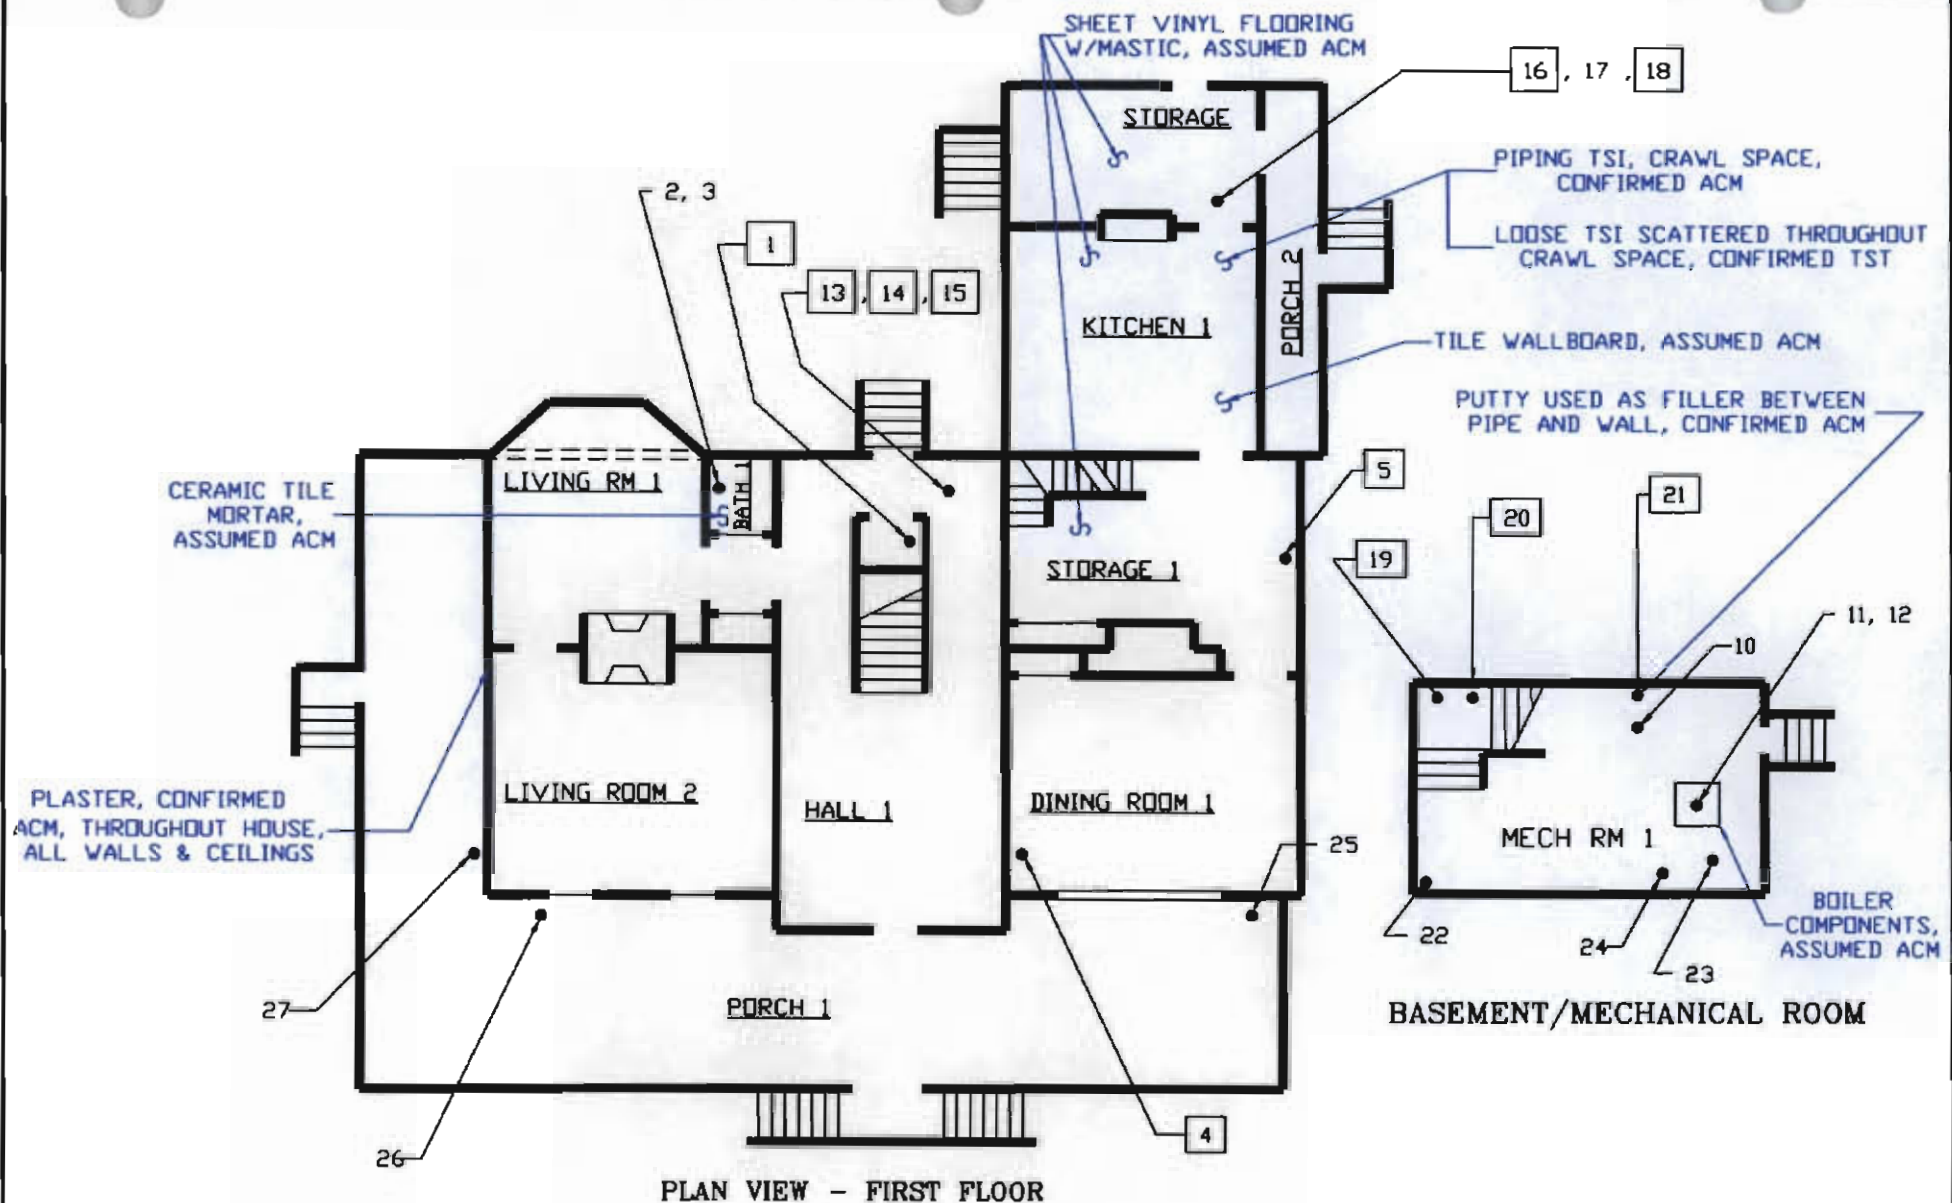
Floor Plan
300 NAVY WAY - QUARTERS "C"
Charleston Naval Base
Charleston, SC

Fourteen homogeneous materials were identified as possible Asbestos Containing Material (ACM). Of the fourteen homogeneous materials, **4 were confirmed to contain asbestos, 4 were assumed to contain asbestos**, and 6 were found to be asbestos free.

Sample No.	ACM Y/N /A	Material Description / LOCATION	Quantity	AHERA CATEGORY	FRIABLE	Cond	% D	Recommended Action	Comments
300-NW-1 300-NW-4 300-NW-5 300-NW-19 300-NW-20	Y Y Y Y Y	PLASTER, walls and ceilings throughout house	15500 sq. ft.	3	YES, only where damaged	G	< 1	Repair	Approx. 2 sq. ft. area damaged in basement
300-NW-13 300-NW-15 300-NW-16 300-NW-17	Y Y Y Y	PIPING TSI, crawl space	460 LF	1	YES	SD	35	REMOVE	ABATEMENT OF THIS MATERIAL IS IN PROGRESS
300-NW-14 300-NW-18	Y Y	SOIL, (loose piping tsi) crawl space	1400 sq. ft.	1	YES	SD	100	REMOVE	ABATEMENT OF THIS MATERIAL IS IN PROGRESS
300-NW-21	Y	MISC. PUTTY / PACKING, used as filler between pipe and brick wall in basement	1 sq. ft.	8	NO	D	20	REMOVE	
ASSUMED	A	MISC. SHEET VINYL FLOORING and MASTIC, kitchen, laundry, storage rooms	630 sq. ft.	6	NO	G	0	O & M	
ASSUMED	A	MISC. TILE WALLBOARD (transite), kitchen	32 sq. ft.	8	NO	G	0	O & M	
ASSUMED	A	MISC. CERAMIC TILE MORTAR, all bathrooms	637 sq. ft.	8	NO	G	0	O & M

ASSUMED	A	BOILER	*	*	*	*	*	*	* see general note # 3

- ASBESTOS TSI IN THE CRAWL SPACE OF QUARTERS C WAS REMOVED DURING FEBRUARY OF 1998.
- ASBESTOS CONTAMINATED SOIL IN CRAWL SPACE OF QUARTERS C WAS ENCAPSULATED WITH CONCRETE IN FEBRUARY OF 1998.
- ALL OTHER ACM FOUND DURING THE INSPECTION COVERED BY THIS REPORT REMAINS IN PLACE.

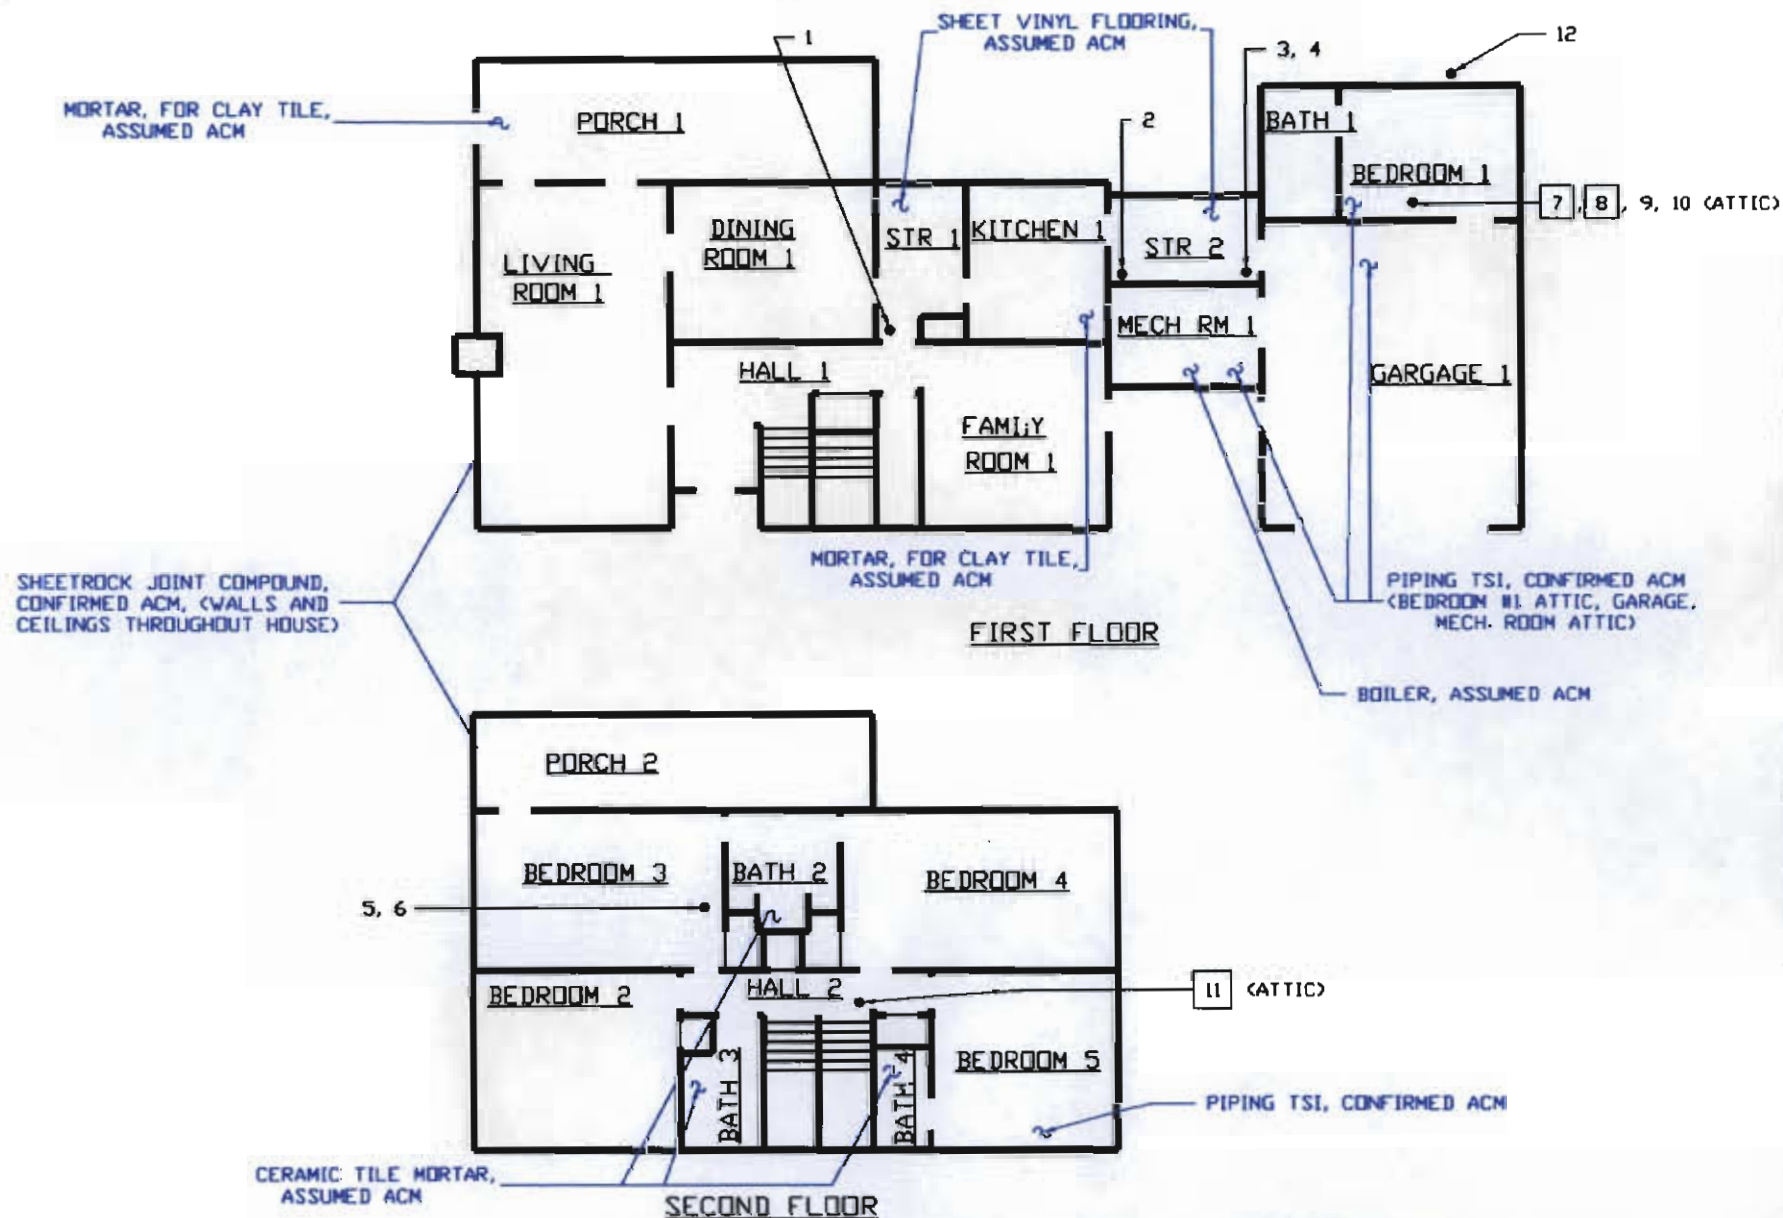
Floor Plan - Type (NH-64)
795 AVENUE "F"
Charleston Naval Base
Charleston, SC

ASSUMED	A	MISC, MORTAR, ceramic tile, all upstairs bathrooms	250 sq. ft.	8	N	G	0	O & M

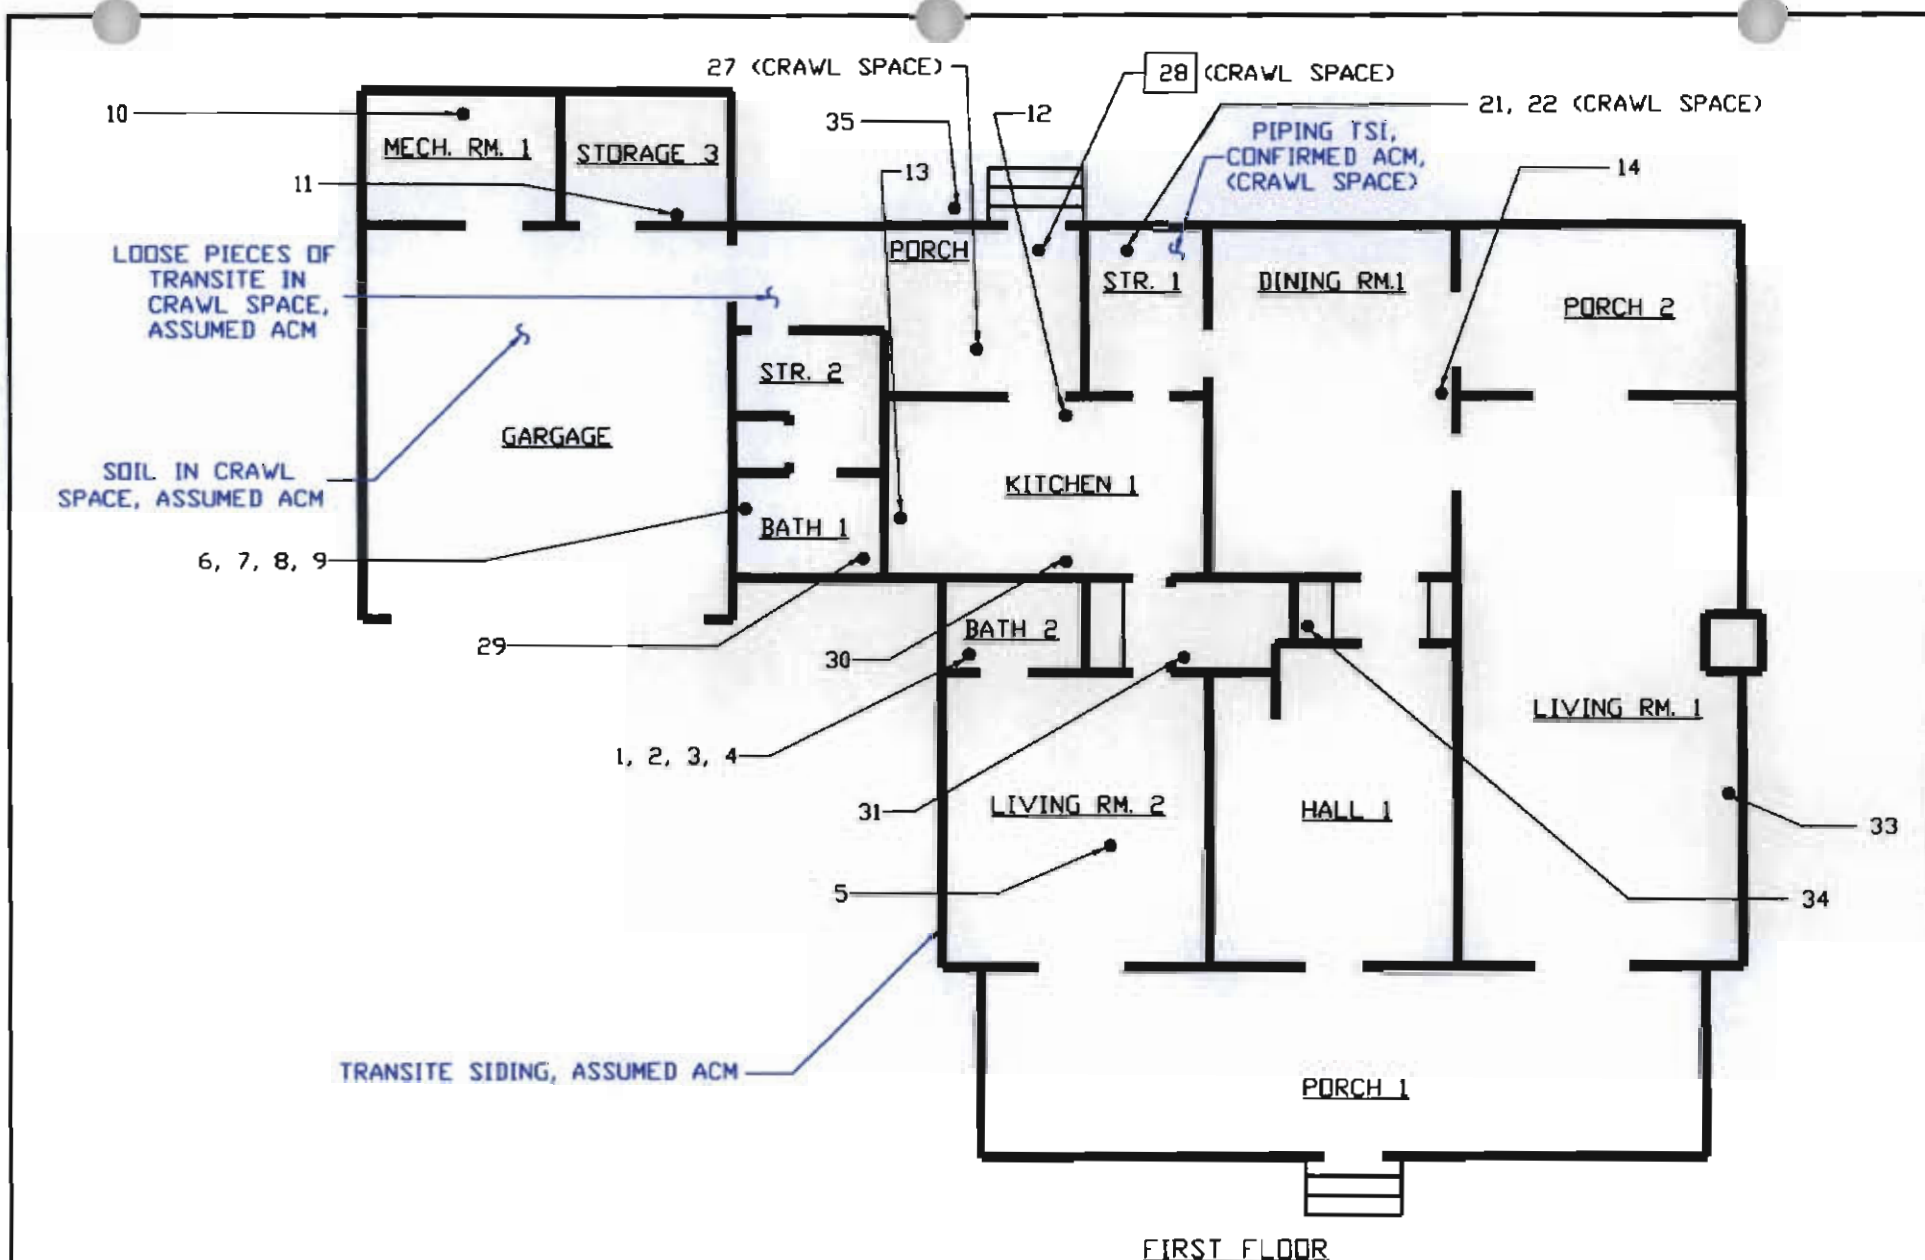
Floor Plan (Type 11)
1510 HOBSON - QUARTERS (Z)
Charleston Naval Base
Charleston, SC

Sample No.	ACM Y/N /A	Material Description / LOCATION	Quantity	AHERA CATEGORY	FRIABLE	Cond	% D	Recommended Action	Comments
1516-HOBSON-7 1516-HOBSON-9 1516-HOBSON-9	Y Y Y	TSI, PIPING, crawl space and attic	125 LF	1	YES	D	10	REMOVE	NOTE: there is also fiberglass piping tsi in the crawl space
1510-HOBSON-28	Y	HVAC DUCT TSI MASTIC, in attic and crawl space, (black mastic)	100 LF	7	NO	G	0	REMOVE or O & M	
ASSUMED	A	MISC. TRANSITE SIDING, house exterior	*	*	*	*	*	*	* assessment not required on exterior materials
ASSUMED	A	MISC. TRANSITE, loose pieces in crawl space	5 sq. ft.	8	NO	D	100	REMOVE	
ASSUMED	A	MISC. TRANSITE SIDING, within enclosed porch	160 sq. ft.	8	NO	G	0	O & M	
ASSUMED	A	MISC., CERAMIC TILE MORTAR, bathrooms 1, 2 and 3	410 sq. ft.	7	NO	G	<1	REPAIR O & M	< 1 sq. ft. damaged in bathroom # 4
ASSUMED	A	SOIL, in crawl space	2000 sq. ft.	1	YES	SD	100	REMOVE	Based on findings at 1516 Hobson

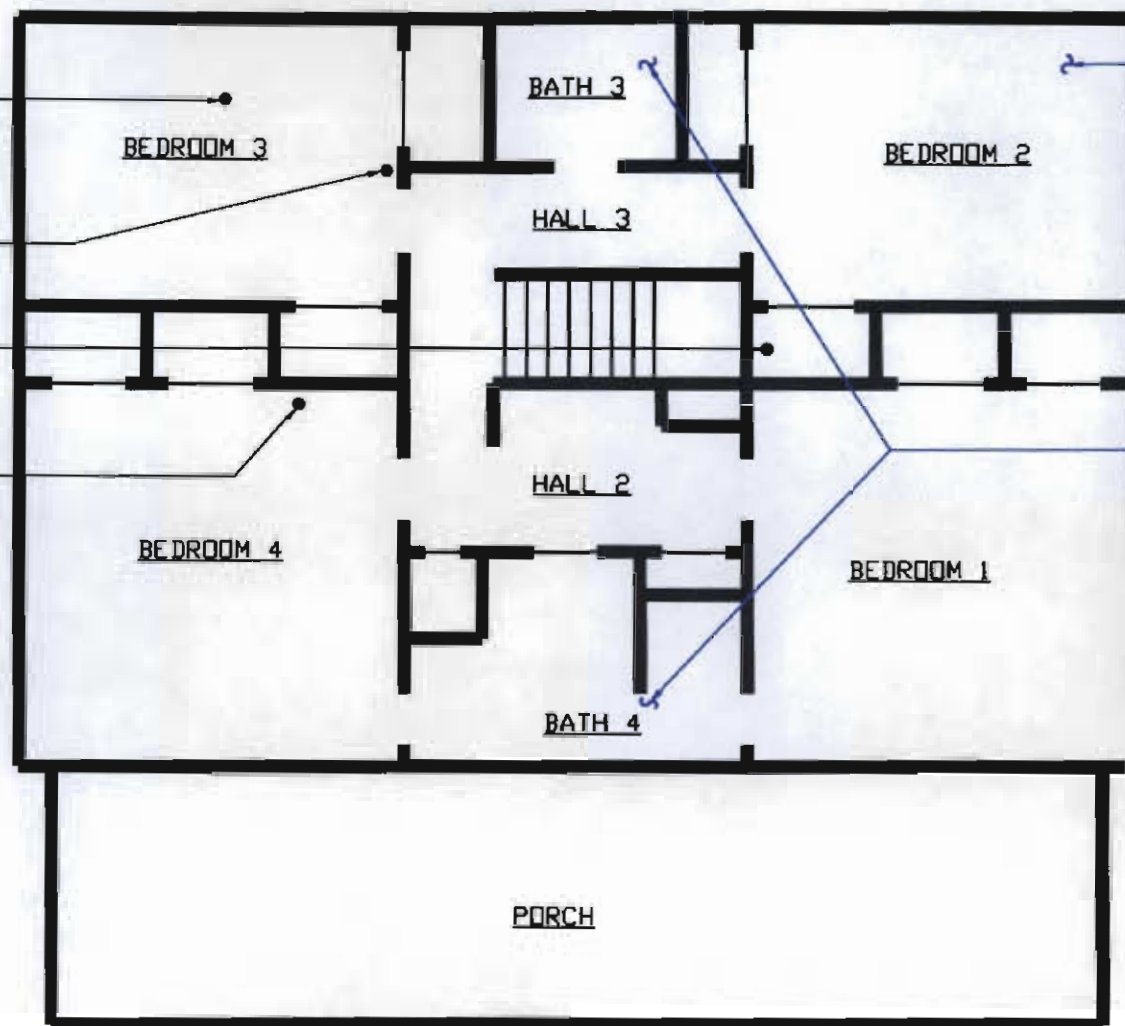
PIPING TSI,
CONFIRMED ACM,
(ATTIC)

CERAMIC TILE MORTAR,
ASSUMED ACM

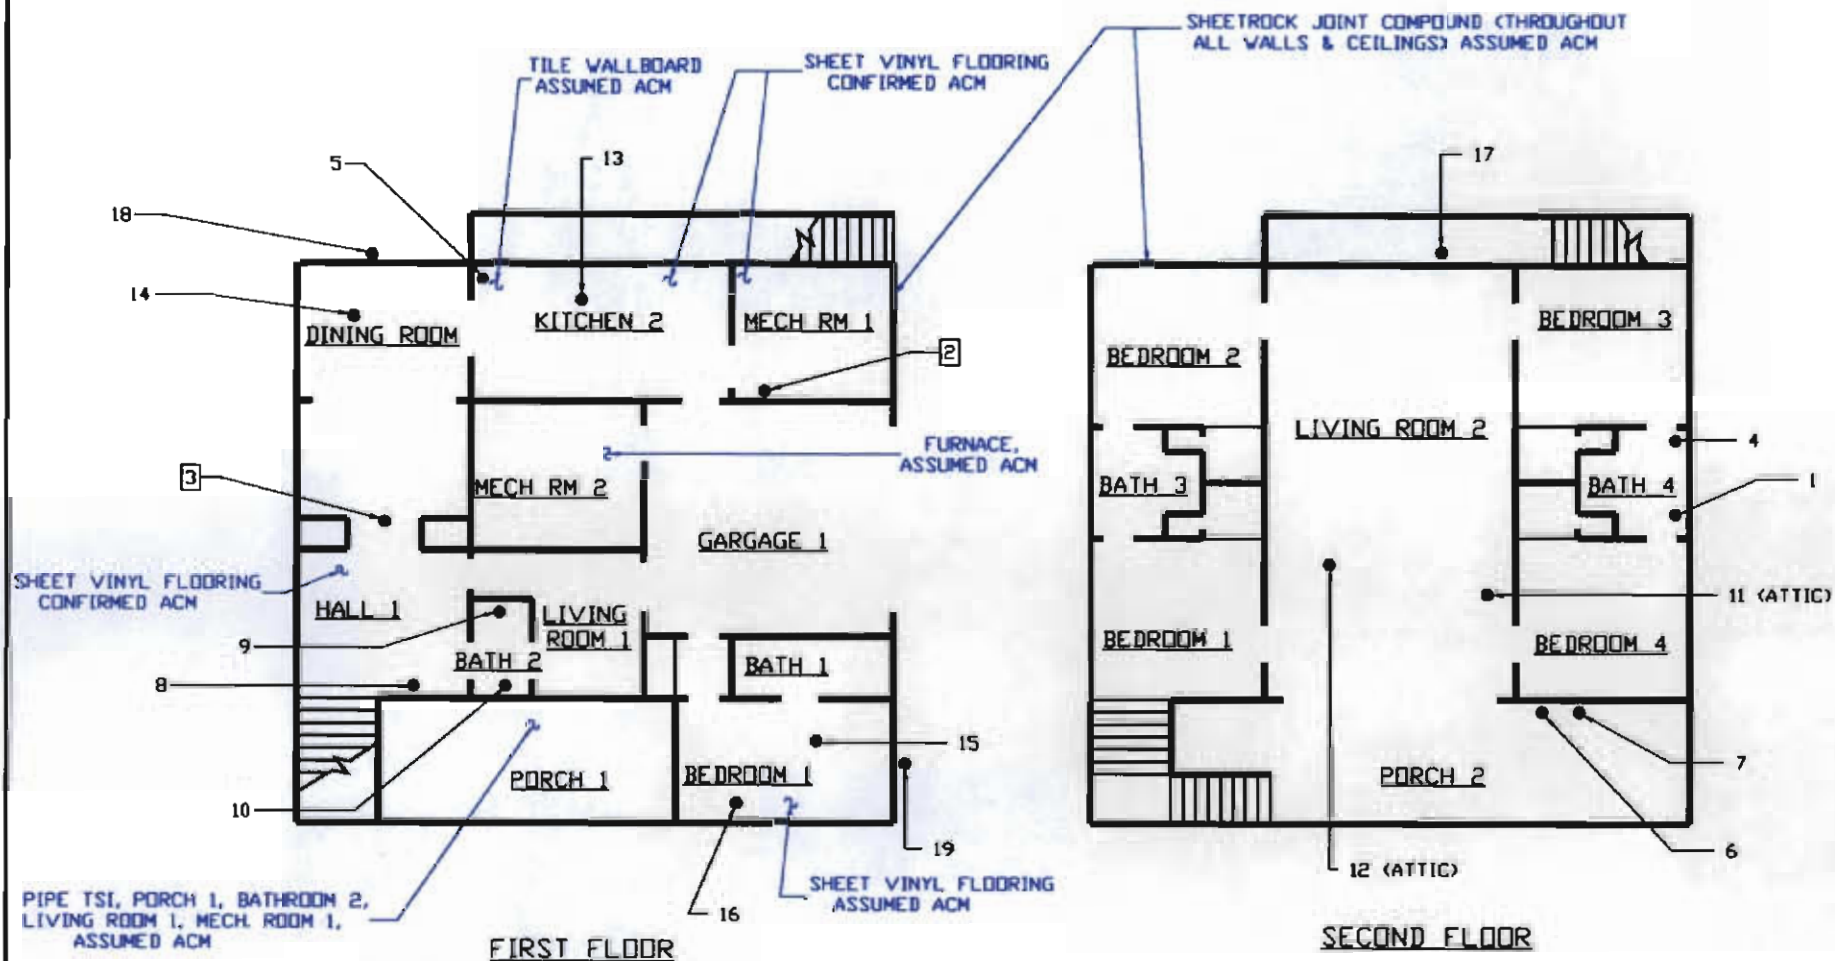
Floor Plan (Type 10)
1531 HOBSON - QUARTERS (T)
Charleston Naval Base
Charleston, SC

Sample No.	ACM Y/N /A	Material Description / LOCATION	Quantity	AHERA CATEGORY	FRIABLE	Cond	% D	Recommended Action	Comments
1531-HOBSON-2 1531-HOBSON-3	Y Y	MISC. SHEET VINYL FLOORING, mech. room # 1 (laundry), living room # 1, kitchen	400 SQ FT	6	NO	G	<1	O & M	
ASSUMED	A	PIPE TSI, bathroom # 2, porch # 1, living room # 1, mech. room # 1	160 LF	6	NO	G	<1	REPAIR O & M	SEE GEN. NOTE # 5
ASSUMED	A	FURNACE	*	*	*	*	*	O & M	SEE GEN. NOTE # 3
ASSUMED	A	WALLBOARD KITCHEN	165 SQ FT	8	NO	G	0	O & M	
ASSUMED	A	MISC SHEETROCK JOINT COMPOUND	8500 SQ FT	6	NO	G	<1	REPAIR O & M	
ASSUMED	A	MISC. SHEET VINYL FLOORING, bedroom # 1, bathroom # 1	170 SQ FT	6	NO	G	<1	O & M

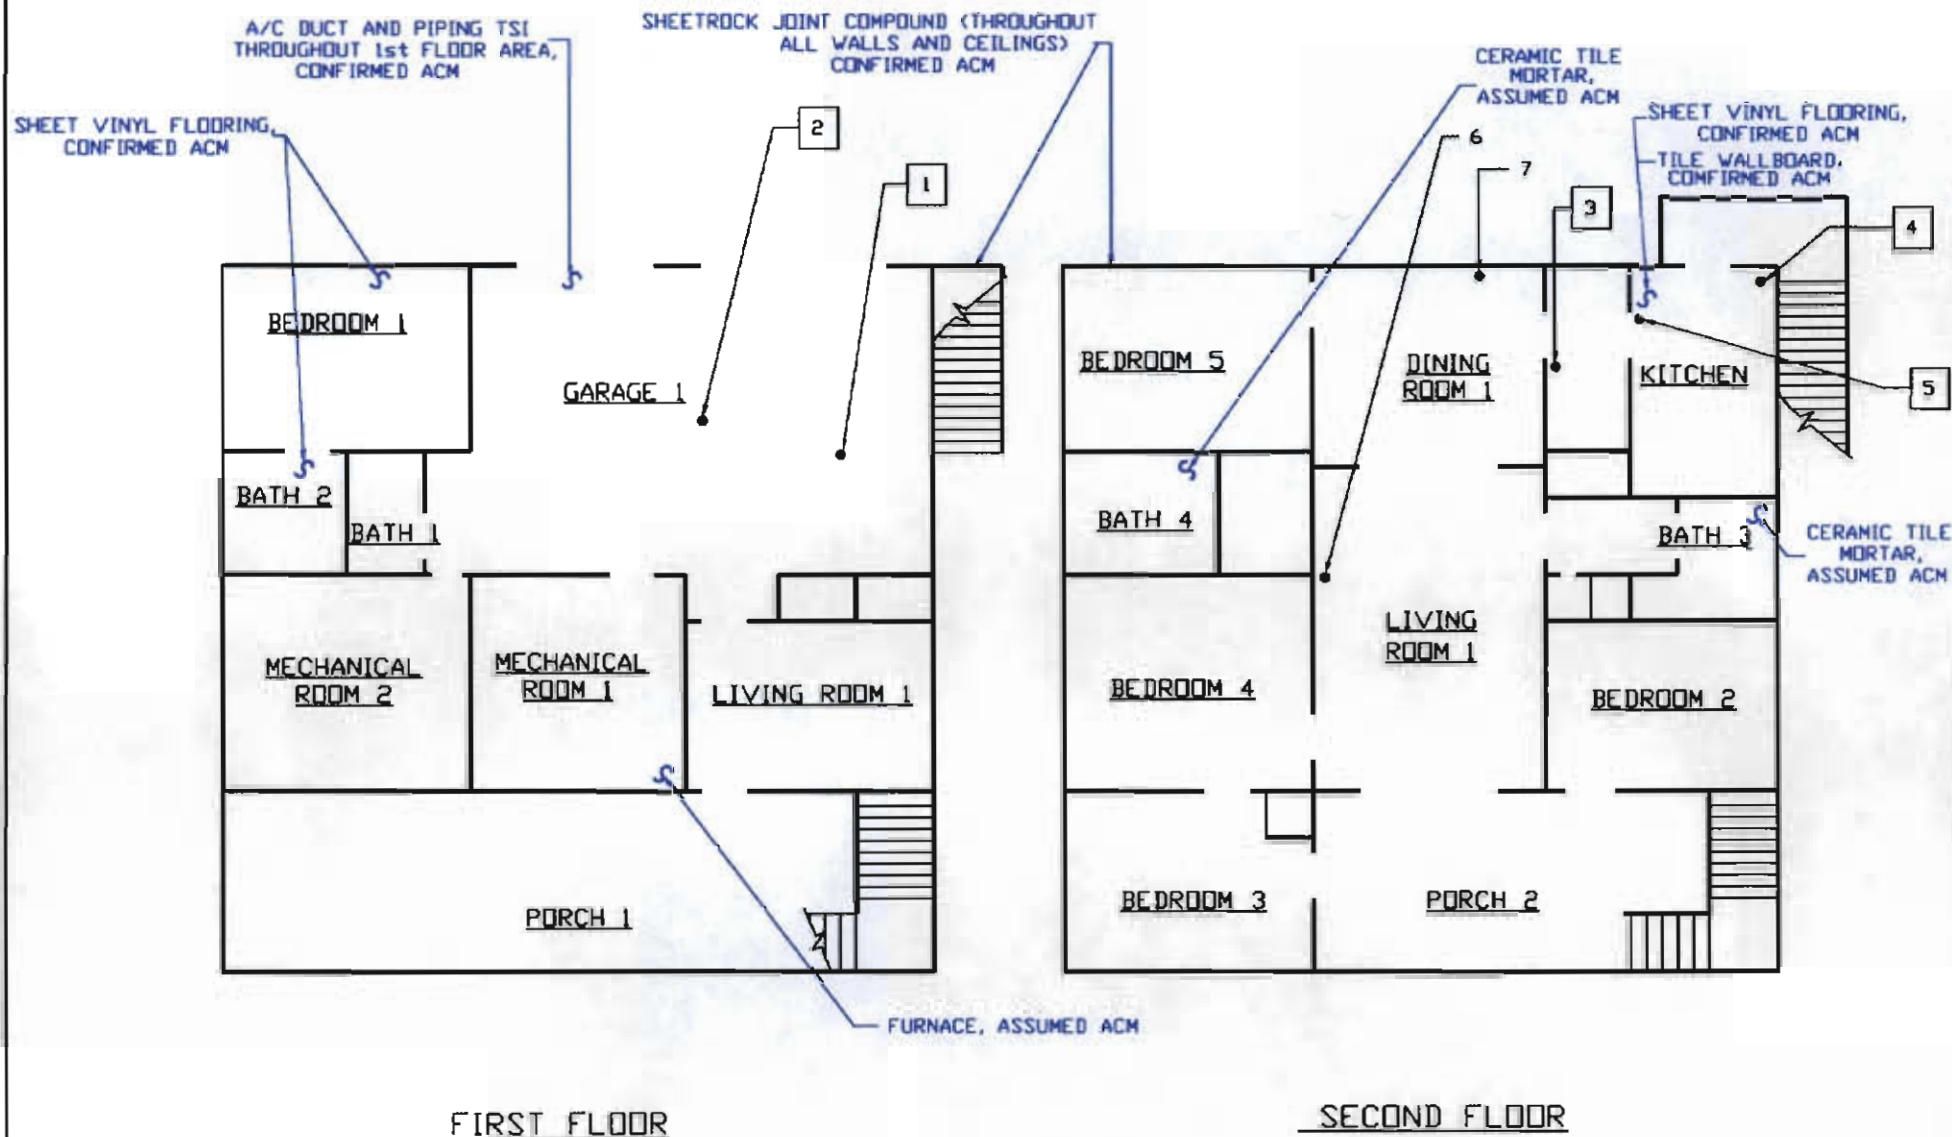
Floor Plan (Type-9)
1505 HOBSON - QUARTERS (Q)
Charleston Naval Base
Charleston, SC

Sample No.	ACM Y/N /A	Material Description / LOCATION	Quantity	AHERA CATEGORY	FRIABLE	Cond	% D	Recommended Action	Comments
1485-HOBSON-2 1485-HOBSON-3 1505-HOBSON-1 1505 -HOBSON-2	Y Y Y Y	TSI, HVAC DUCT	700 Sq. Ft.	1	YES	D	10%	REPAIR , O & M	
1599 -HOBSON-2 1599-HOBSON-3	Y Y	MISC., SHEET VINYL FLOORING, kitchen, bedroom 1, bath #2	509 Sq. Ft.	6	NO	G	0	O & M	
1505-HOBSON-3 1565HOBSON-3	Y Y	MISC, TILE WALLBOARD kitchen	150 Sq. Ft.	8	NO	G	0		
1485-HOBSON-1	Y	TSI, PIPING 1 ST floor	140 LF	6	NO	G	0	O & M	Gen. Note 5
152-TURNBULL-2 150-TURNBULL-1 150-TRUNBULL-2 150-TURNBULL-3 1565-HOBSON-1 1565-HOBSON-2 1599-HOBSON-1	Y* N N N N N N	MISC. SHEETROCK JOINT COMPOUND, walls and ceilings throughout house	8200 Sq. Ft., (Gen. Note 1)	6	YES, only where damaged	G	< 1	O & M	Approx. 4 Sq. Ft., damaged in mech. room
NONE	A	TSI, FURNACE	*	*	*	*	*	O & M	Gen. Note 3
NONE	A	MISC, CERAMIC TILE MORTAR, baths 3 & 4	450 Sq. Ft.	8	NO	G	0	O & M

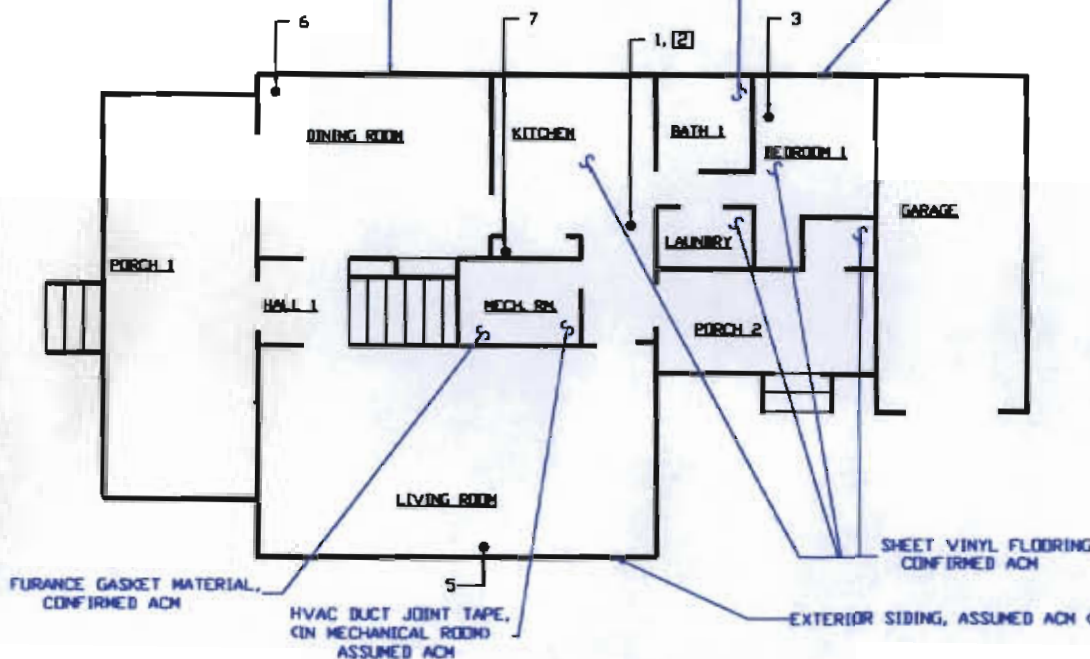
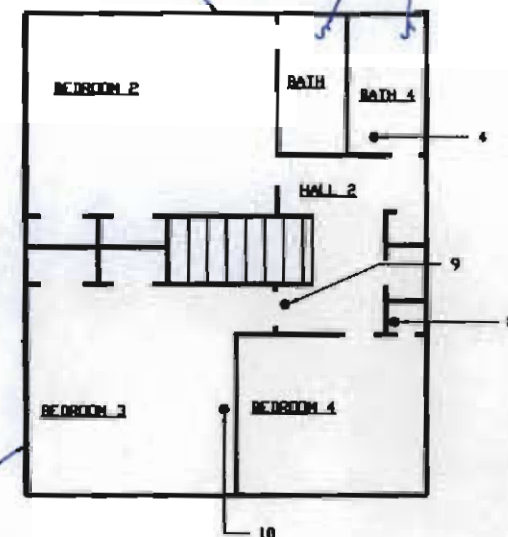
SHEETROCK JOINT COMPOUND (THROUGHOUT
ALL WALLS & CEILINGS) CONFIRMED ACM

CERAMIC TILE MORTAR,
ASSUMED ACM

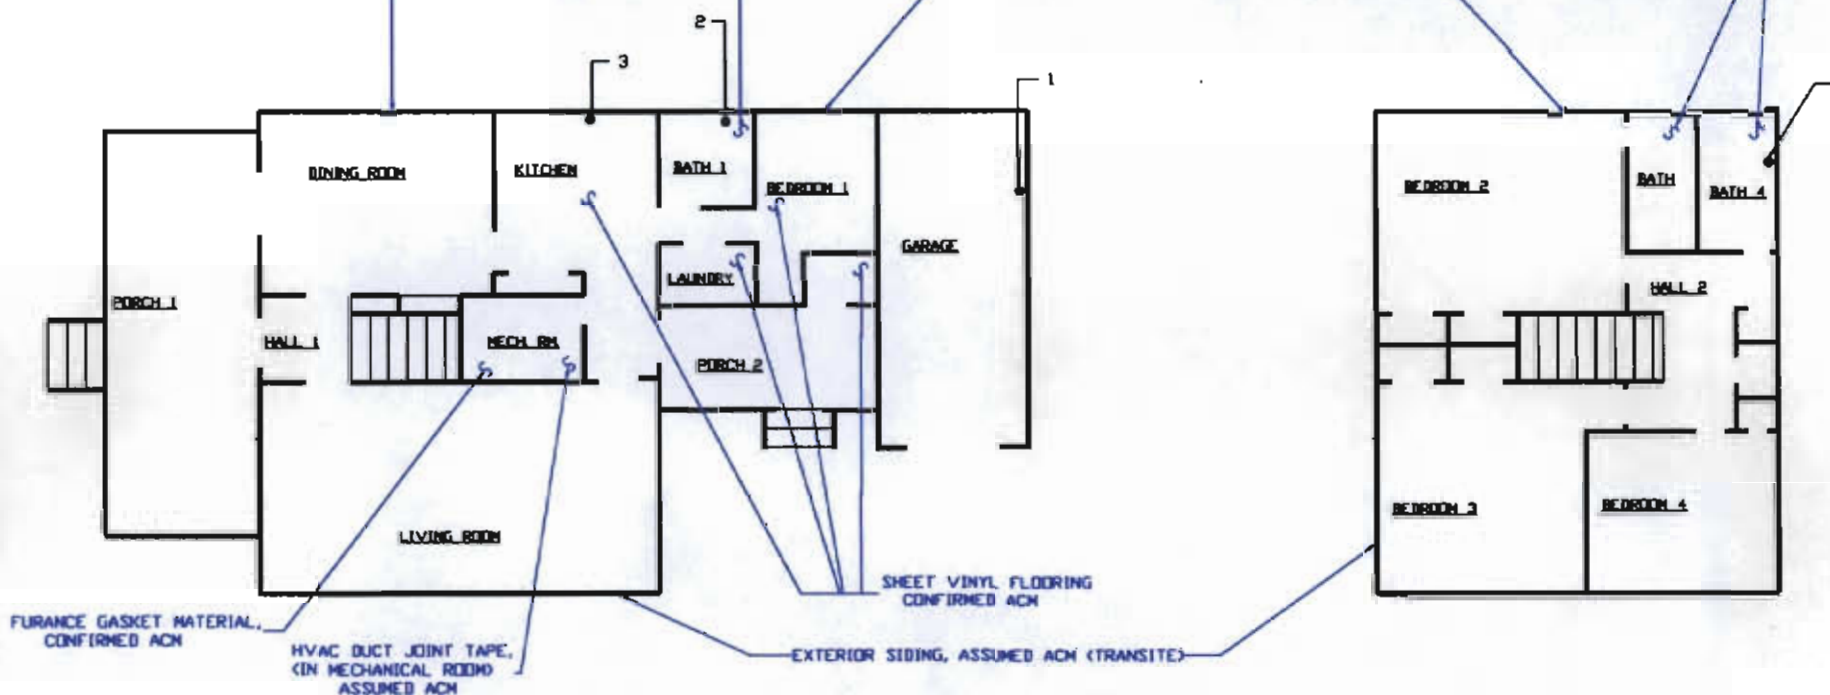
SHEETROCK JOINT COMPOUND (THROUGHOUT
ALL WALLS & CEILINGS) CONFIRMED ACM

CERAMIC TILE MORTAR,
ASSUMED ACM

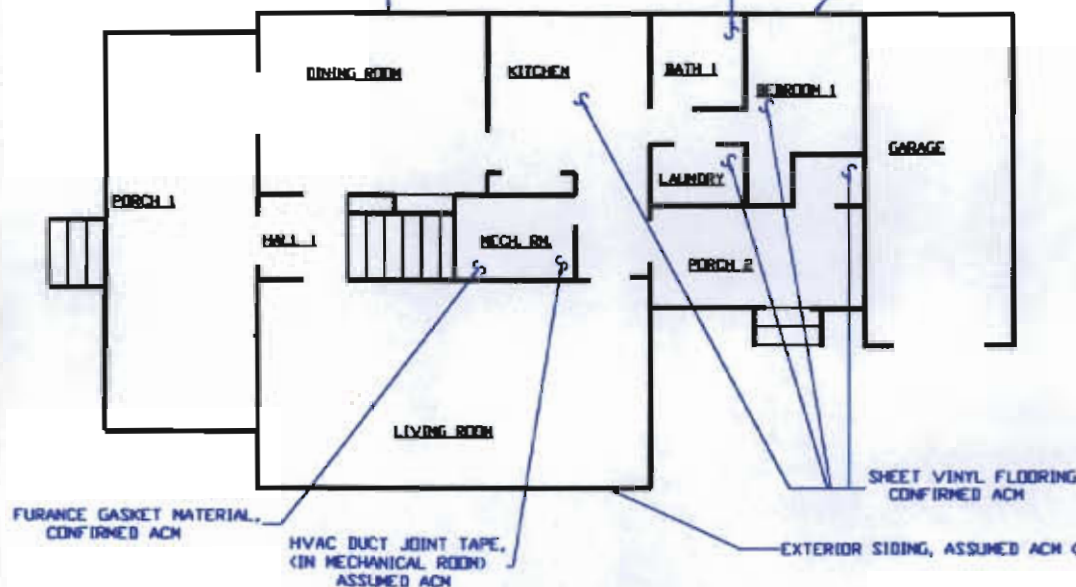
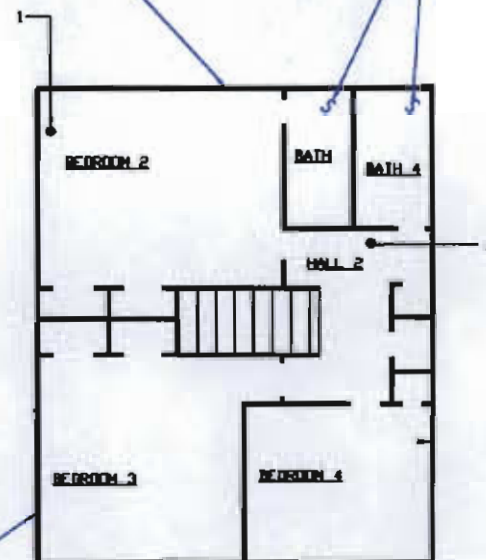
SHEETROCK JOINT COMPOUND (THROUGHOUT ALL WALLS & CEILINGS) CONFIRMED ACM

CERAMIC TILE MORTAR, ASSUMED ACM

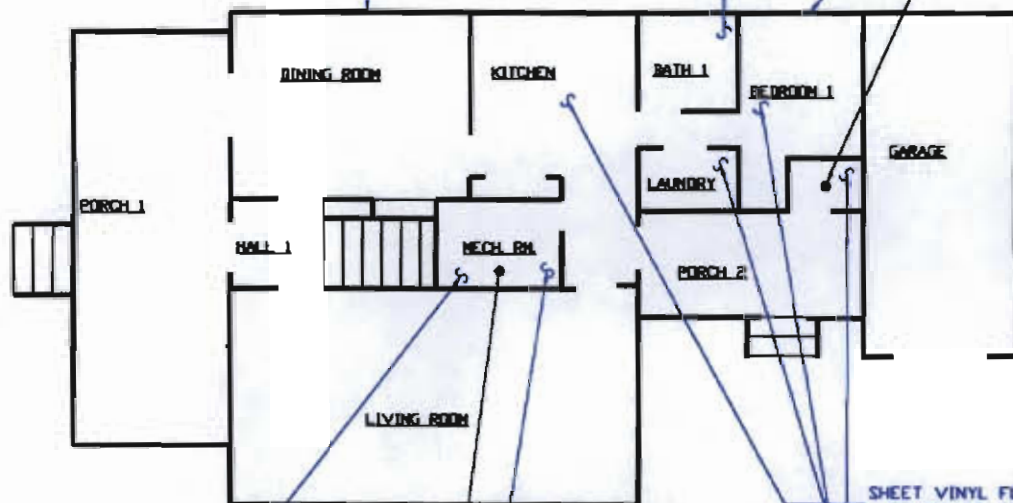
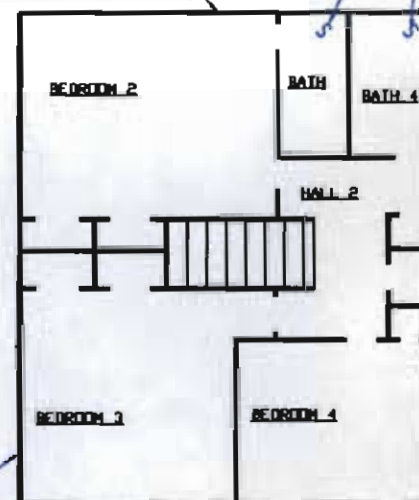
SHEETROCK JOINT COMPOUND (THROUGHOUT
ALL WALLS & CEILINGS) CONFIRMED ACM

CERAMIC TILE MORTAR,
ASSUMED ACM

FURANCE GASKET MATERIAL,
CONFIRMED ACM

HVAC DUCT JOINT TAPE,
IN MECHANICAL ROOM
ASSUMED ACM

EXTERIOR SIDING, ASSUMED ACM (TRANSITE)

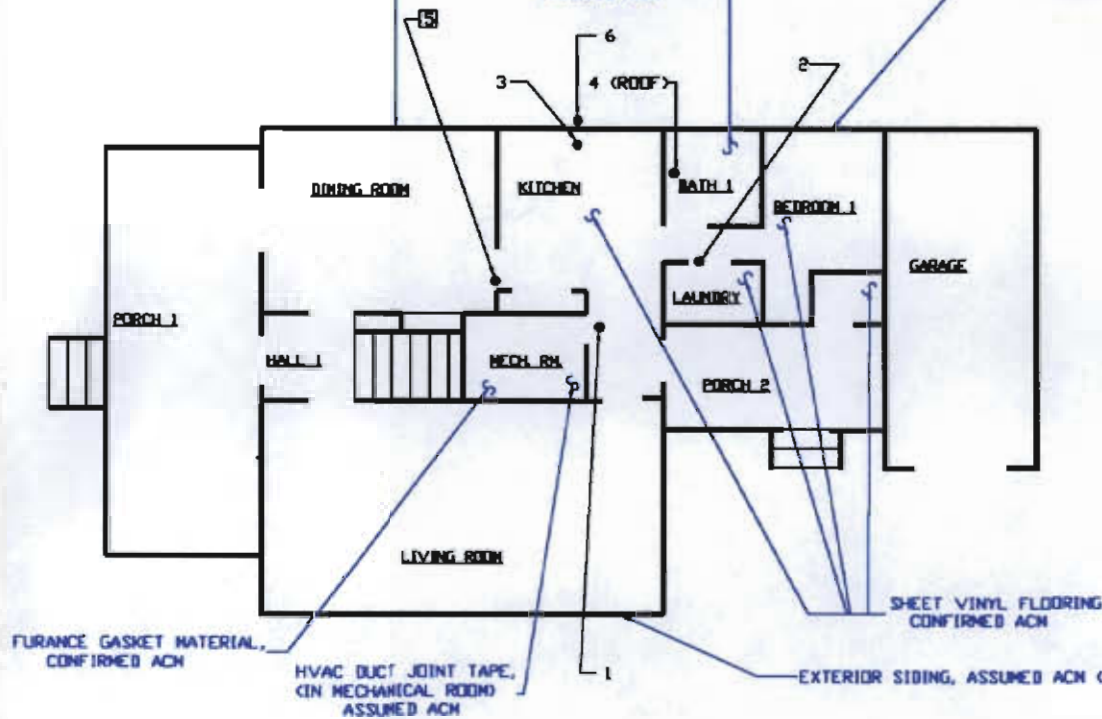
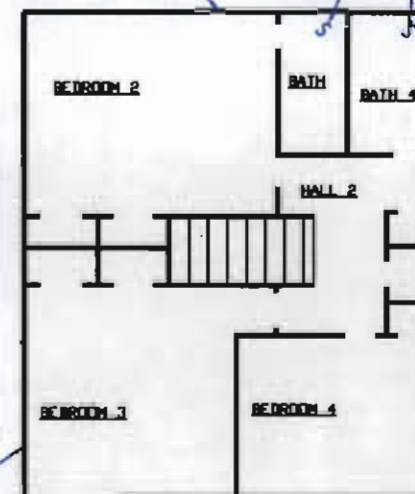
SHEETROCK JOINT COMPOUND (THROUGHOUT
ALL WALLS & CEILINGS) CONFIRMED ACM

CERAMIC TILE MORTAR,
ASSUMED ACM

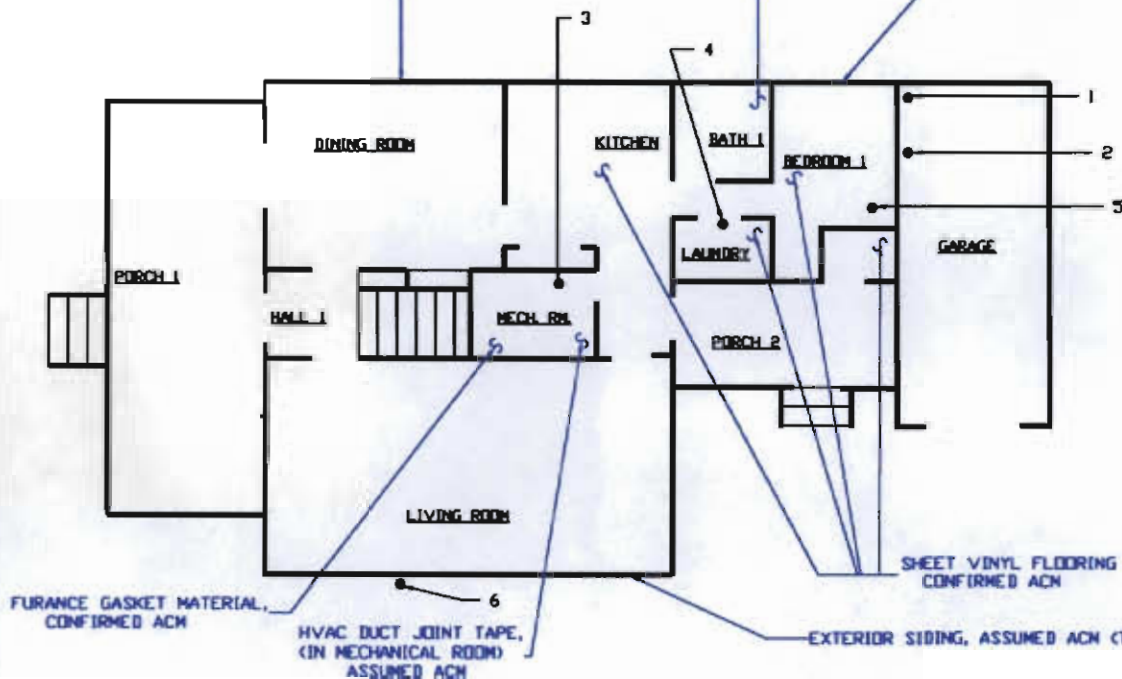
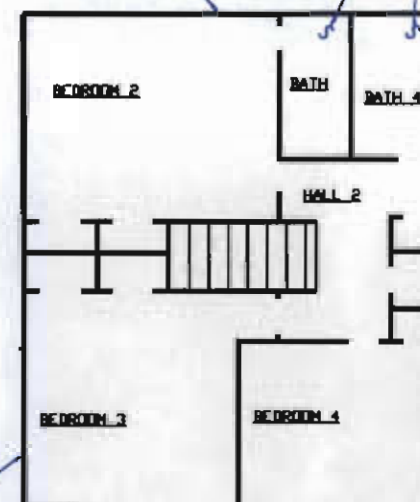
SHEETROCK JOINT COMPOUND (THROUGHOUT
ALL WALLS & CEILINGS) CONFIRMED ACM

CERAMIC TILE MORTAR,
ASSUMED ACM
